# A comparative study of measured and computed stresses in the Thirteenth street bridge over Skunk River near Ames, Iowa

A COMPARATIVE STUDY OF MEASURED AND COMPUTED  
STRESSES IN THE THIRTEENTH STREET BRIDGE  
OVER SKUNK RIVER NEAR AMES IOWA

A Thesis submitted to the Graduate Faculty  
for the Degree of

Structural Engineering

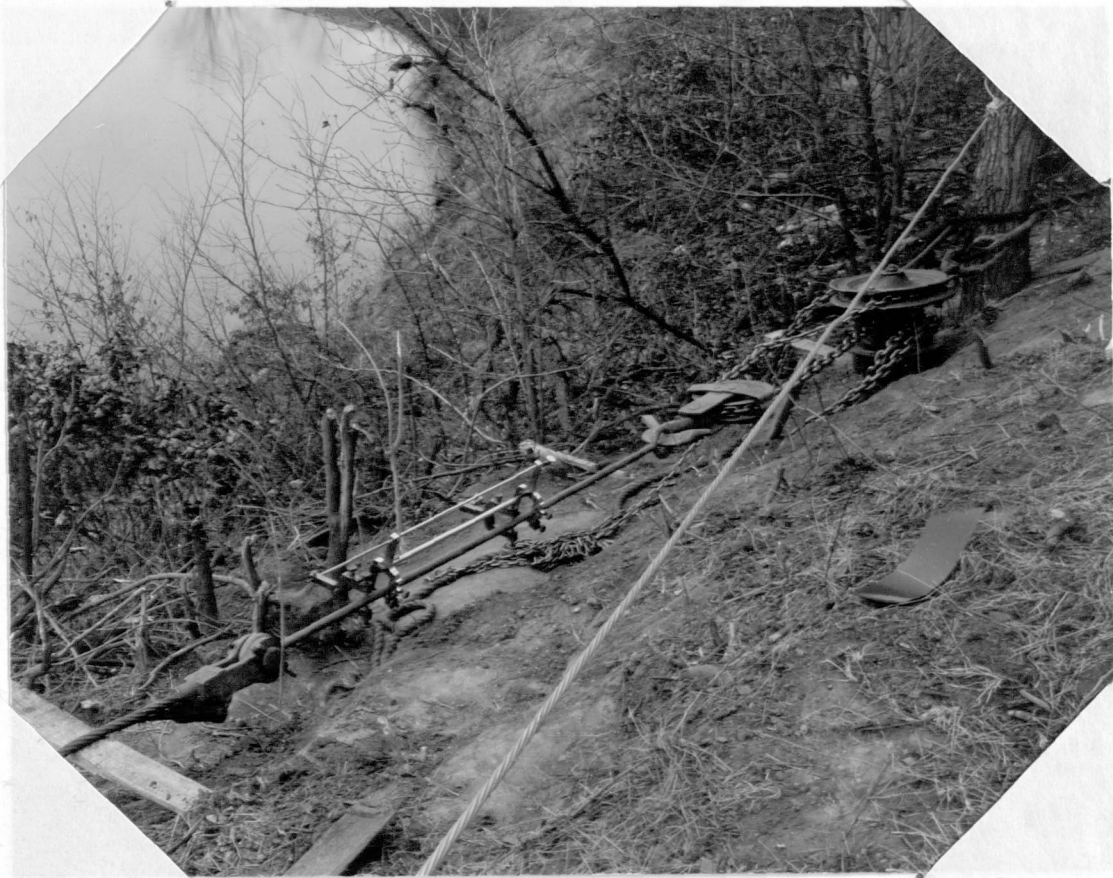
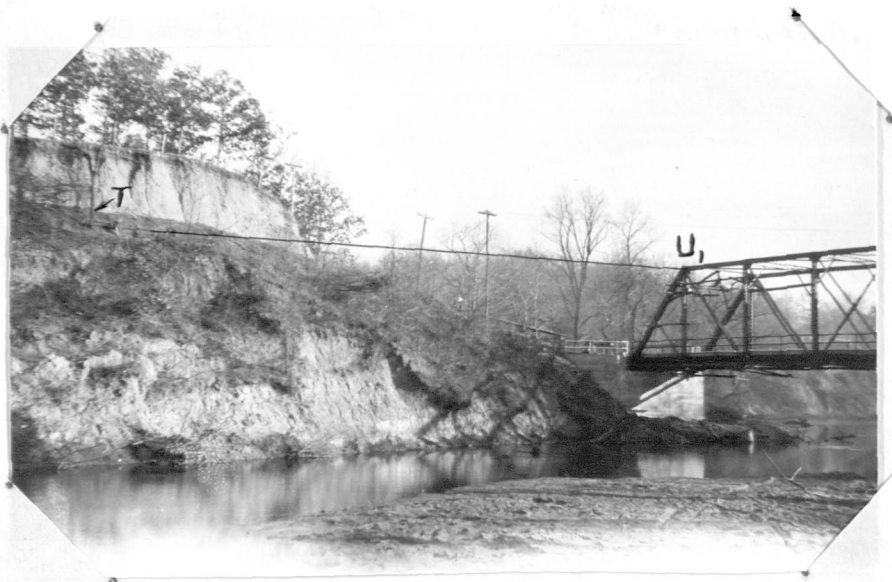
FIG. 5. VIEWS SHOWING MANNER IN WHICH  
WIND LOAD WAS APPLIED.

Load. The load used to represent a wind load was applied horizontally at the panel point U1 and was about 8,000 pounds. This is approximately the wind load for which the portal members were designed. As shown in the small view in Fig. 5, the contour of the ground near the east end of the bridge was such as to make this investigation possible. The tree marked T in this photo is located at about the elevation of the panel point U1 and is almost exactly in line with the portal head strut. This afforded an excellent anchorage for the hoist and cable used in applying the load as is shown in the large view

of Fig. 5. A  $\frac{3}{4}$ -inch bar was placed between the hoist and the cable for the purpose of measuring the applied load. This photo shows the arrangement and the manner in which 20-inch West extensometers were used for measuring the load. After the field work was completed this bar was taken into the laboratory and calibrated in a testing machine. Fig. 1 shows the manner in which the cable was fastened at U1.
